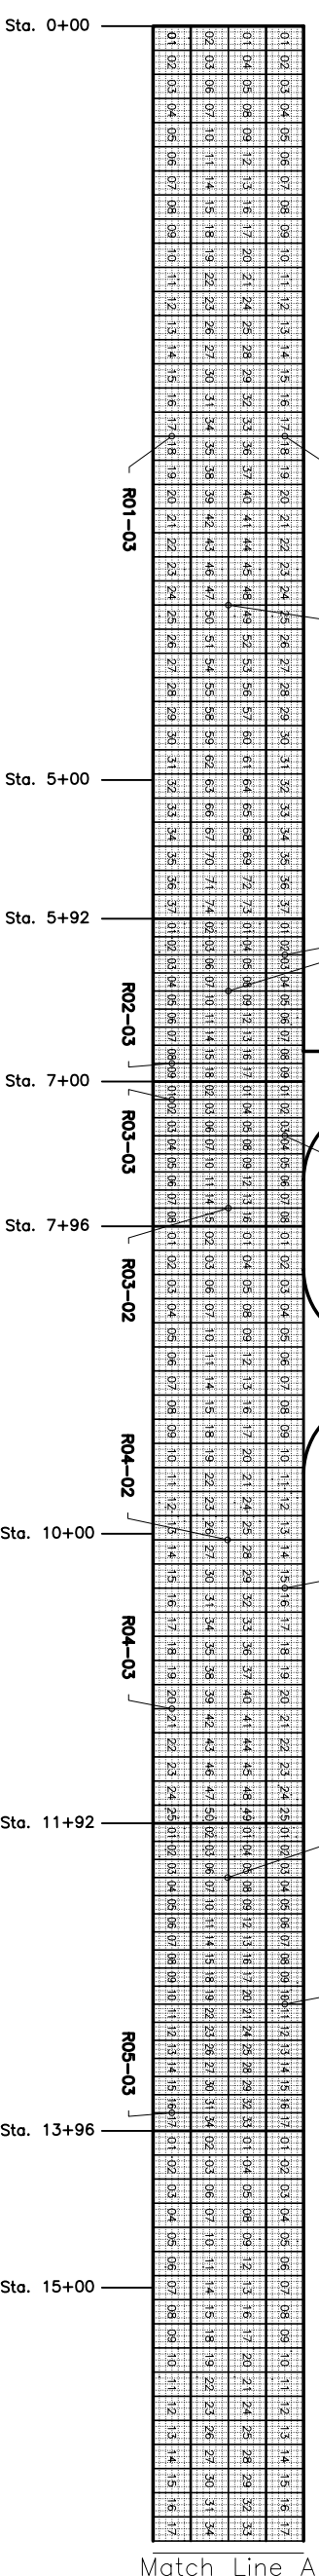
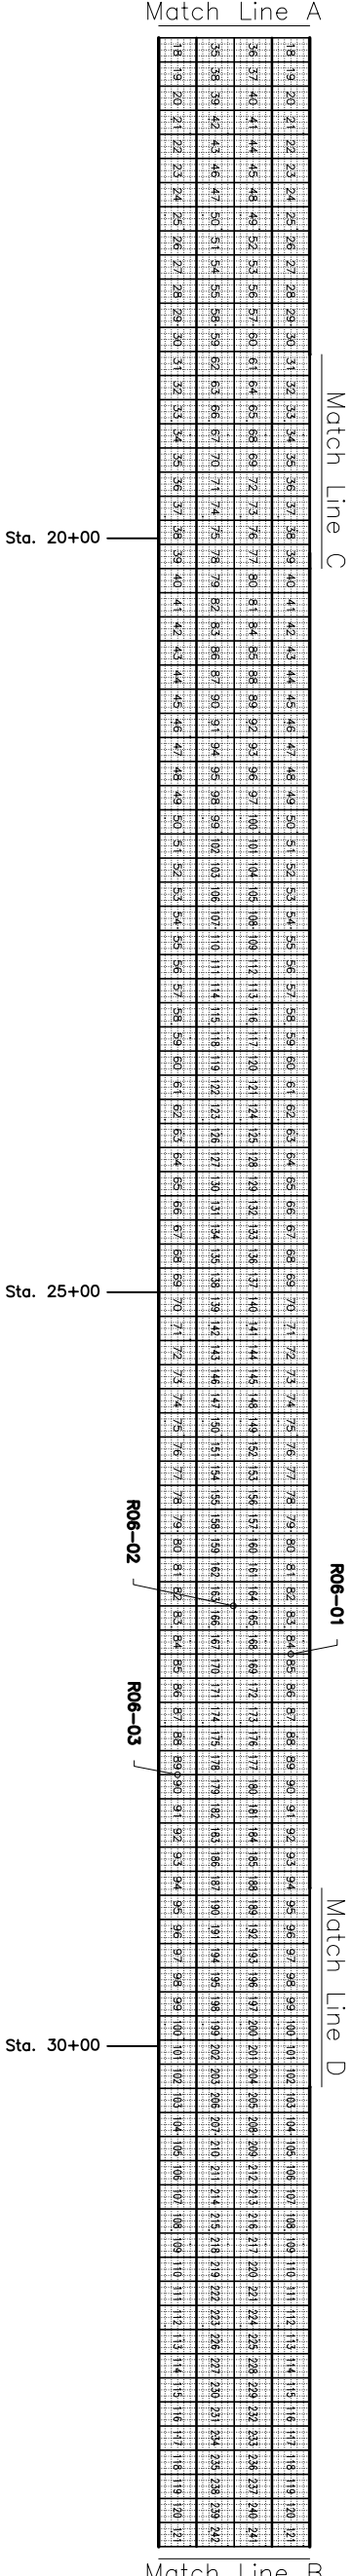
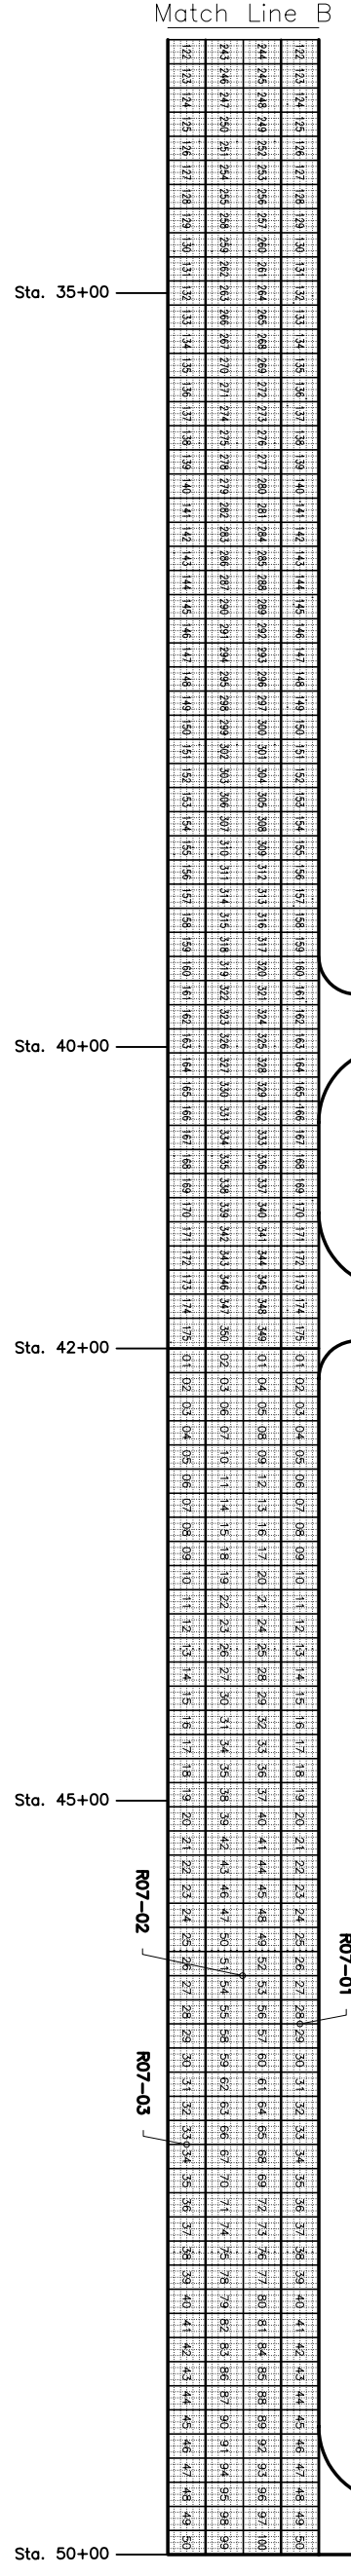
Figure 2.7. Sample unit layout for Runway 18-36 at Savannah-Hardin County Airport.

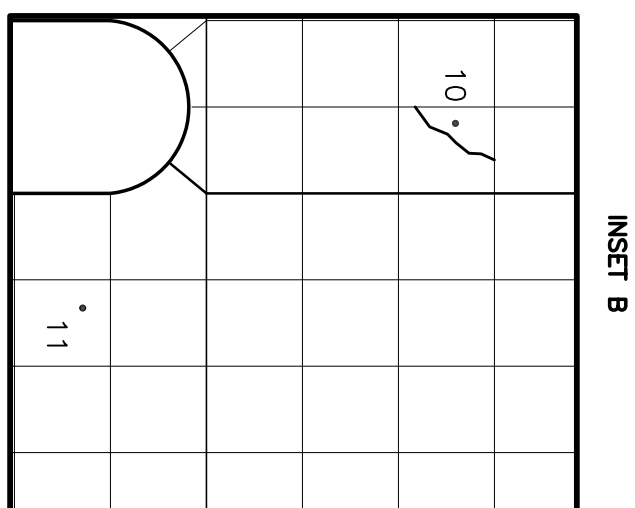
- Cores 5 and 12 were not taken.
- Insets are not to scale.
- Represents area with steel reinforcement.
- Represents core location and number.
- Represents a crack in the pavement.
- Condition of slabs only in the vicinity of cores is indicated.

Figure 2.46. Location of cores removed at Life Bridge Christian Church.
